**LAND USE PLANNING AND DEVELOPMENT SUITABILITY
IN
QUEENSTOWN, NEW ZEALAND**

A thesis submitted in partial fulfilment of the requirements for the
Degree of Masters of Engineering Geology
at the
University of Canterbury

by
Virginia Cunningham

University of Canterbury
1994

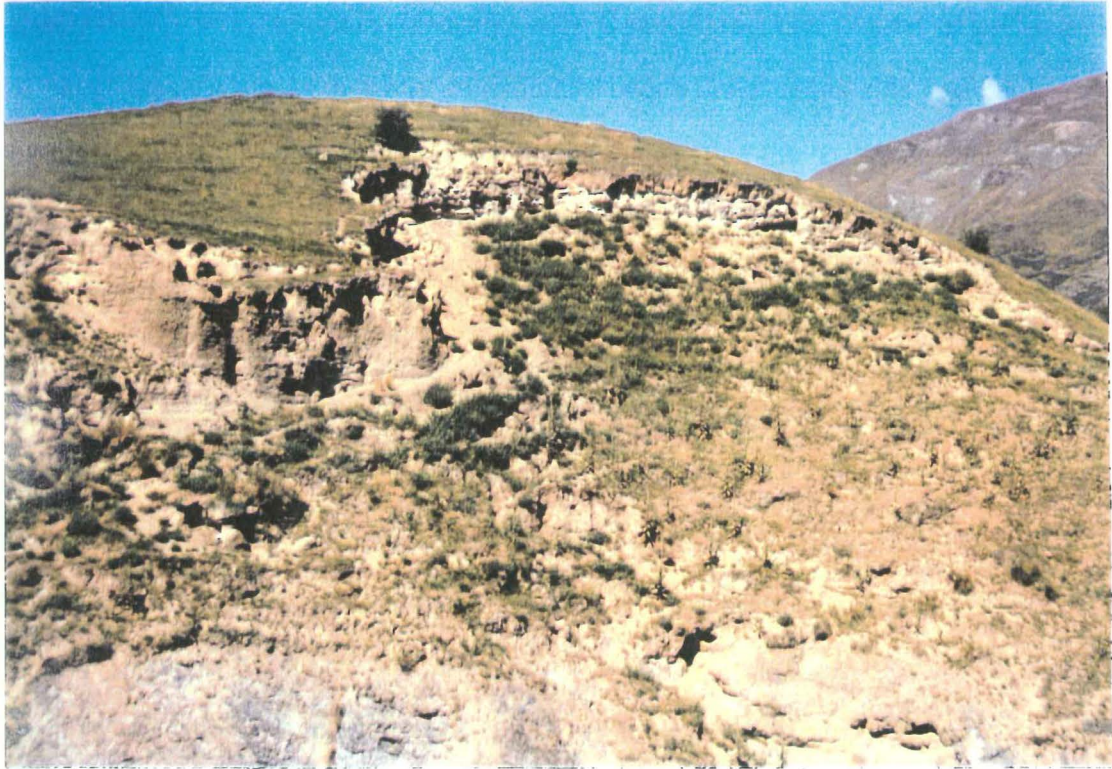
Figure 12: Post-Waitiri deltaic - lacustrine sedimentary sequence, Crown Terrace. Steeply dipping, pelitic greyschist is overlain by a succession of interbedded gravelly sand, silt, and bedded sandy fine to medium gravel (centre left), which fines progressively upwards into anastomosing layers of bedded silts (upper right).

A small gully towards the southern end of the terrace exposes a 15m thick succession of interlayered gravelly sands, sands and silts overlying slightly kinked pelitic greyschist at an elevation of approximately 560m asl (Figure 12). A gravelly sand with sand layers is overlain by one to two metres of compact, massive fine sandy silt, which in turn grades up into a 4m of loose to compact, poorly sorted, massive fine sandy fine to medium gravel with occasional cobbles and a trace of micaceous silt. This gravel is slightly imbricated and gently to moderately inclined to the northwest, and is predominantly subangular to subround greyschist with abundant greenschist and occasional greywacke. It fines upwards into a thinly layered fine gravel, inclined to the northwest, with layers of silt which become thicker and more frequent upwards until the outcrop is dominated by thick anastomosing beds of silt with medium sandy fine gravel between.

These sediments are inferred to represent interglacial fluvial-deltaic-lacustrine sediments deposited in bedrock depressions cut by post-Waitiri fluvial activity (contemporaneous with the Eastburn lacustrine sediment).

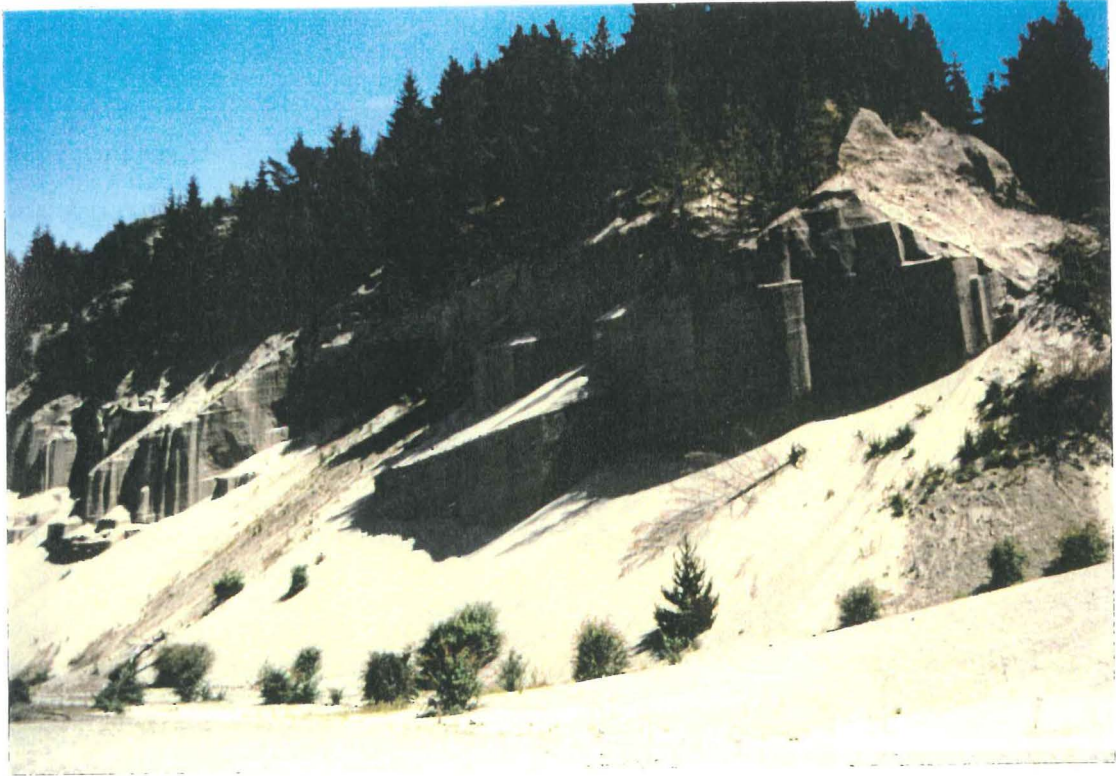
Figure 15: 20 to 40m of interbedded sand and sandy gravel of the Dalefield fluvioglacial deposit, overlain by the Dalefield till (upper left). The irregular, erosional contact is marked by the tree line.

The two deposits are separated by an irregular, erosional contact. The compact gravel is interpreted as a till deposited during a readvance of ice from the west/northwest. Overlying the till, separated from it by a sharp erosional contact, are two to ten metres of interbedded and crossbedded fine and medium sands, subhorizontal to gently incline to the northwest.

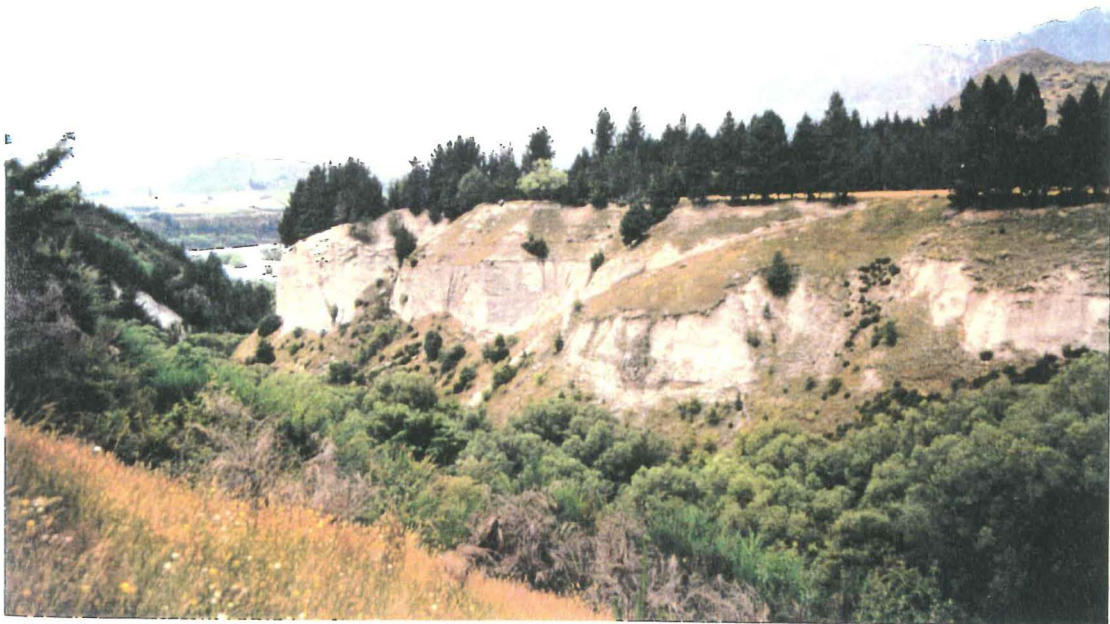
Figure 16: Cross-bedded sands in sharp contact with the underlying compact, sandy gravel (Dalefield Till) exposed in a deeply incised gully below Dalefield. View is to the southeast, with the Shotover River in the distance.

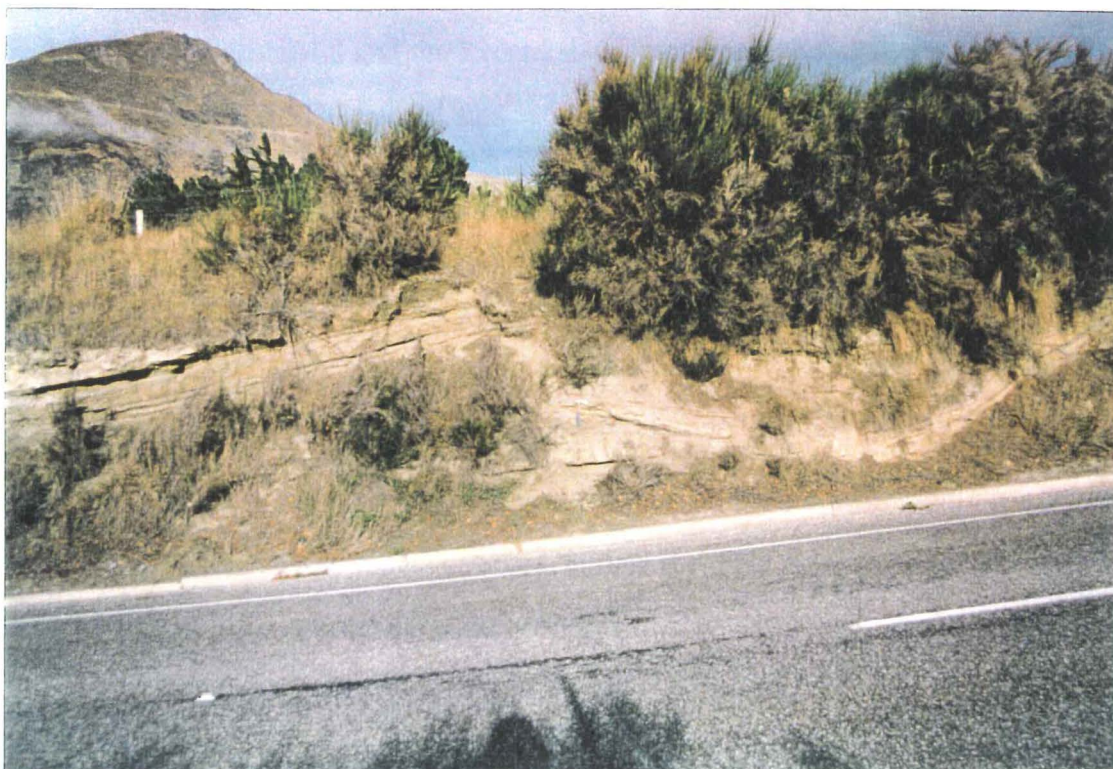
Figure 17: Finely bedded lacustrine silt exposed along S.H.6 south of Lake Hayes (view towards the south). The deformation is inferred to be the result of consolidation and differential settlement within the silt unit as it became stranded by the progressive lowering of Lake Wakatipu.

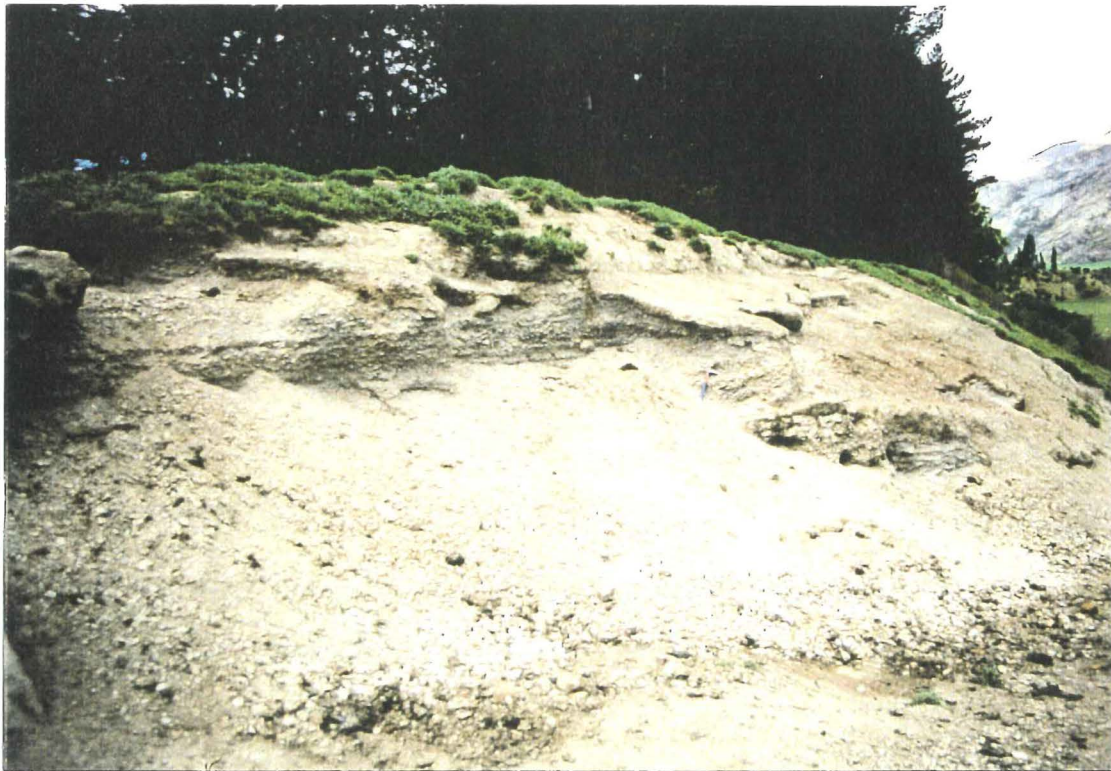
Figure 19: Deltaic, sandy fine to medium gravel exposed in a river-cut bank below the Ladies Mile Flat aggradation surface. Contains several lenses of silt and sand.

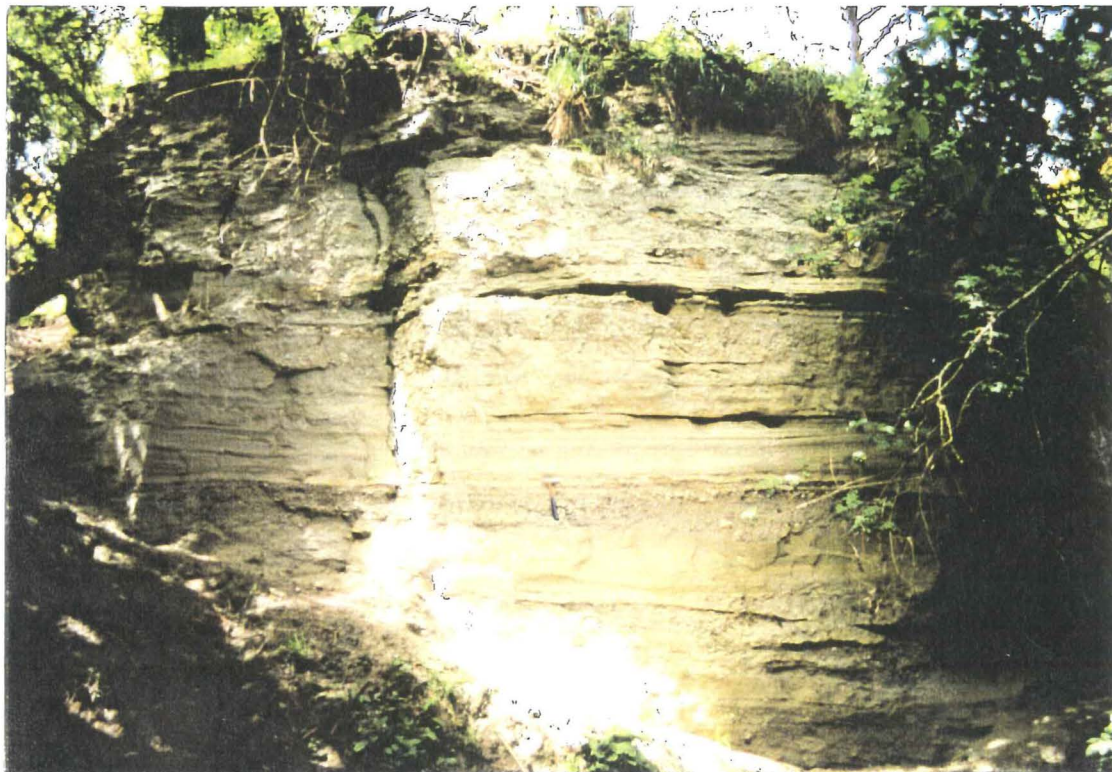
Figure 20: Six to eight metres of sub-horizontal interlayered silts, very fine sands, and sandy fine gravels. This succession is interpreted as representing periodic (possibly seasonal) influx of coarser material into a low energy (lacustrine) environment. Note the deformation of the fine grained layers (load structures).

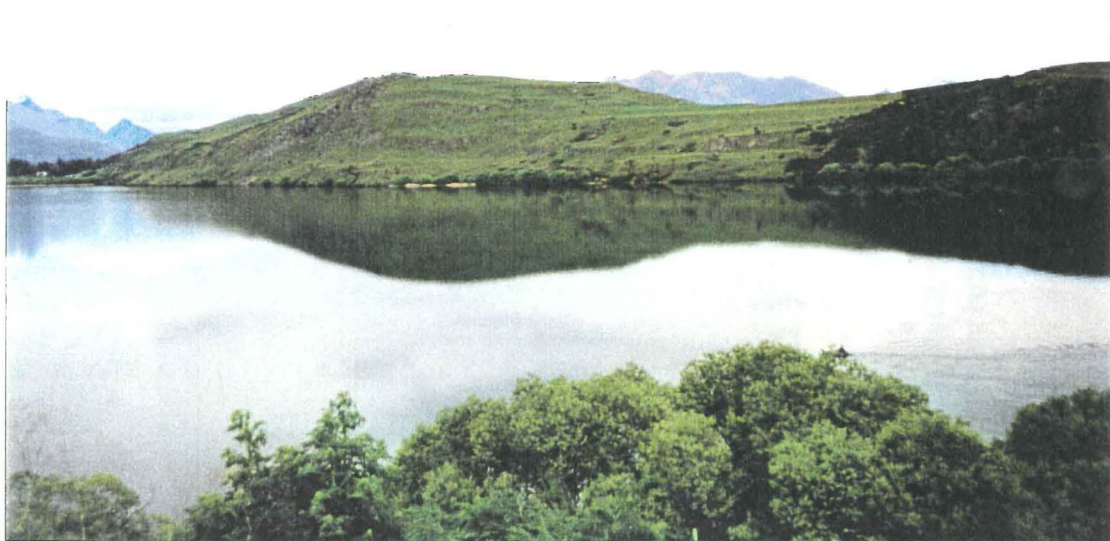
Figure 21: Relict beach terraces preserved above Lake Hayes that represent higher lake levels of approximately 400m, 365m and 330m asl (Greater Lake Wakatipu). View is towards the southwest.

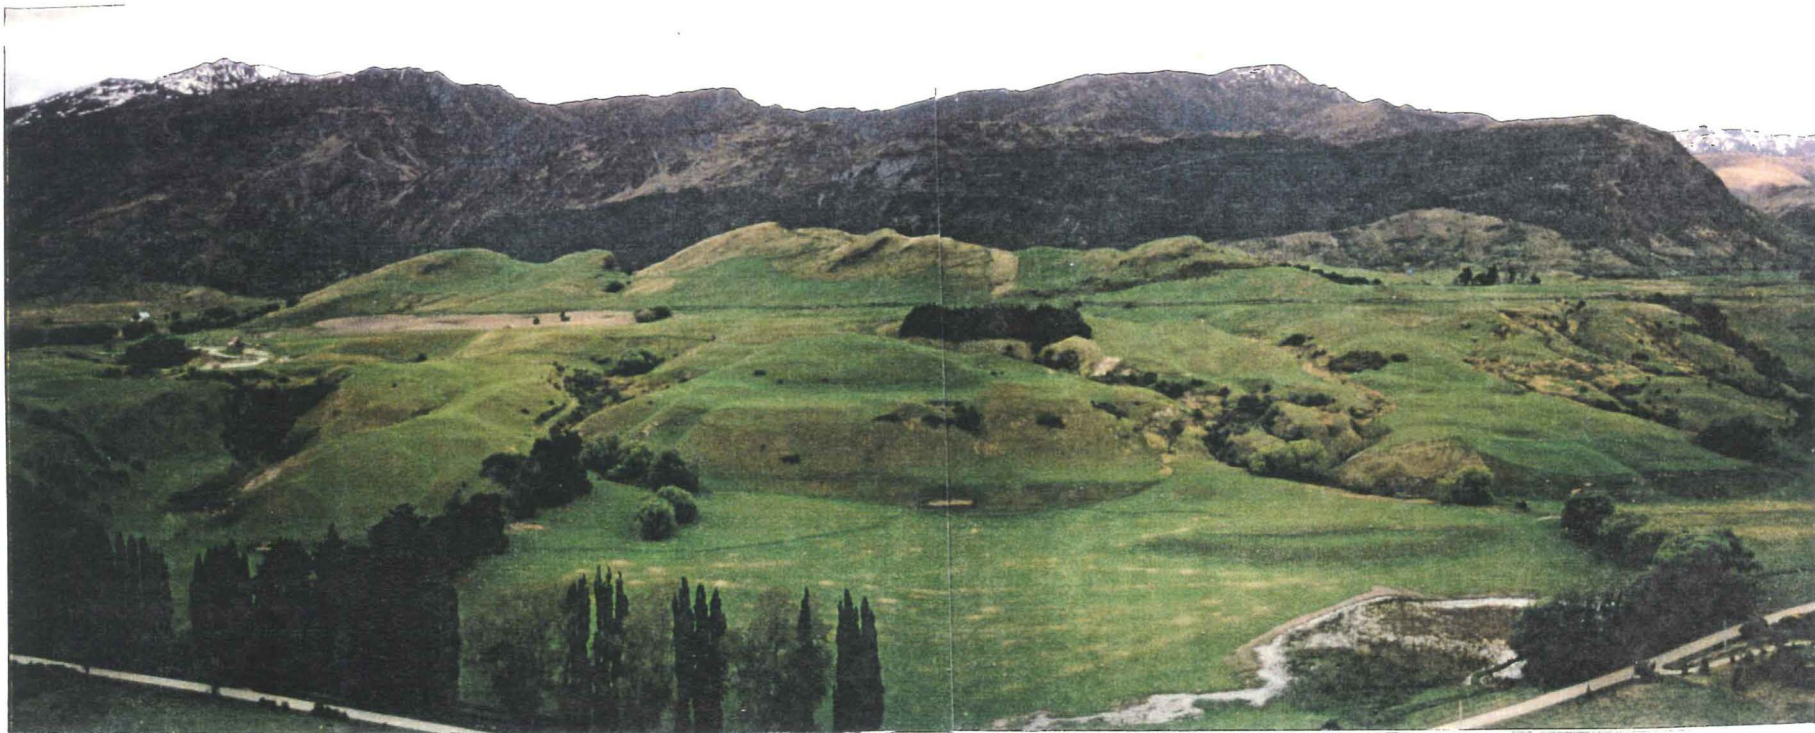
Figure 22: High level lake bench above Speargrass Flat Road at approximately 400m asl. Small truncated fan-deltas in valley probably built out at a lake level of approximately 380m asl. View to the north.

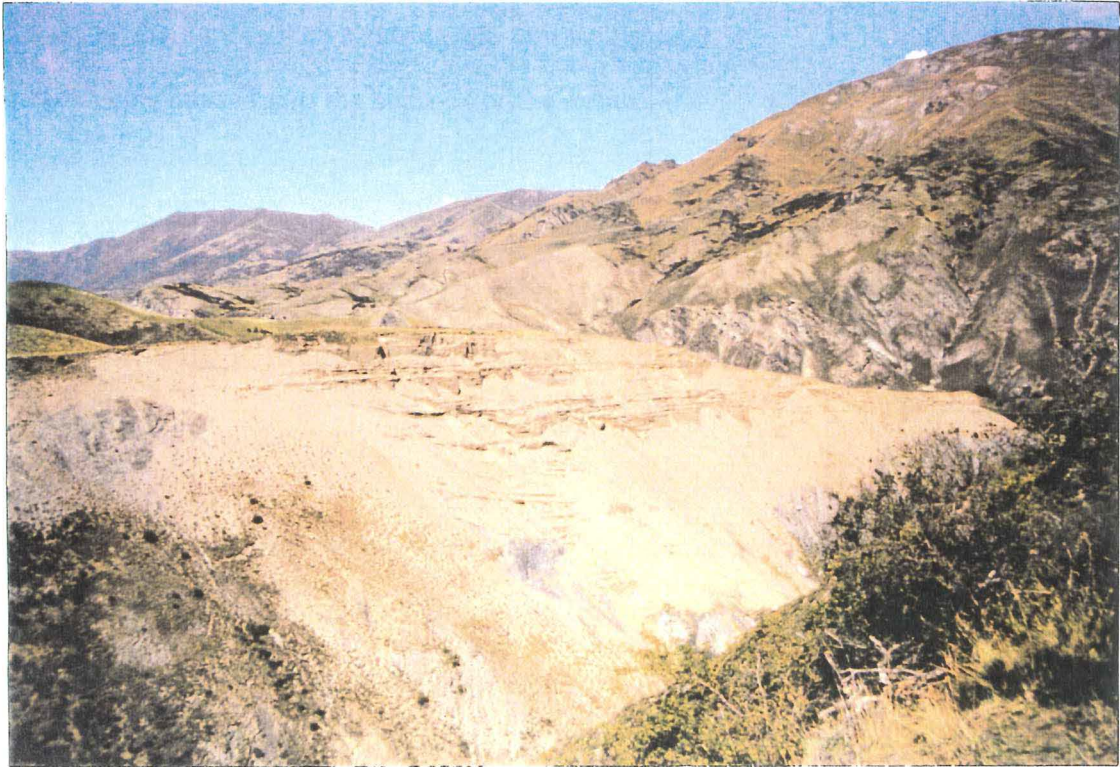
Figure 23: Otiran-age alluvial fan gravels overlying bedrock, Crown Terrace. Note the deeply incised gully. View is to the southeast.

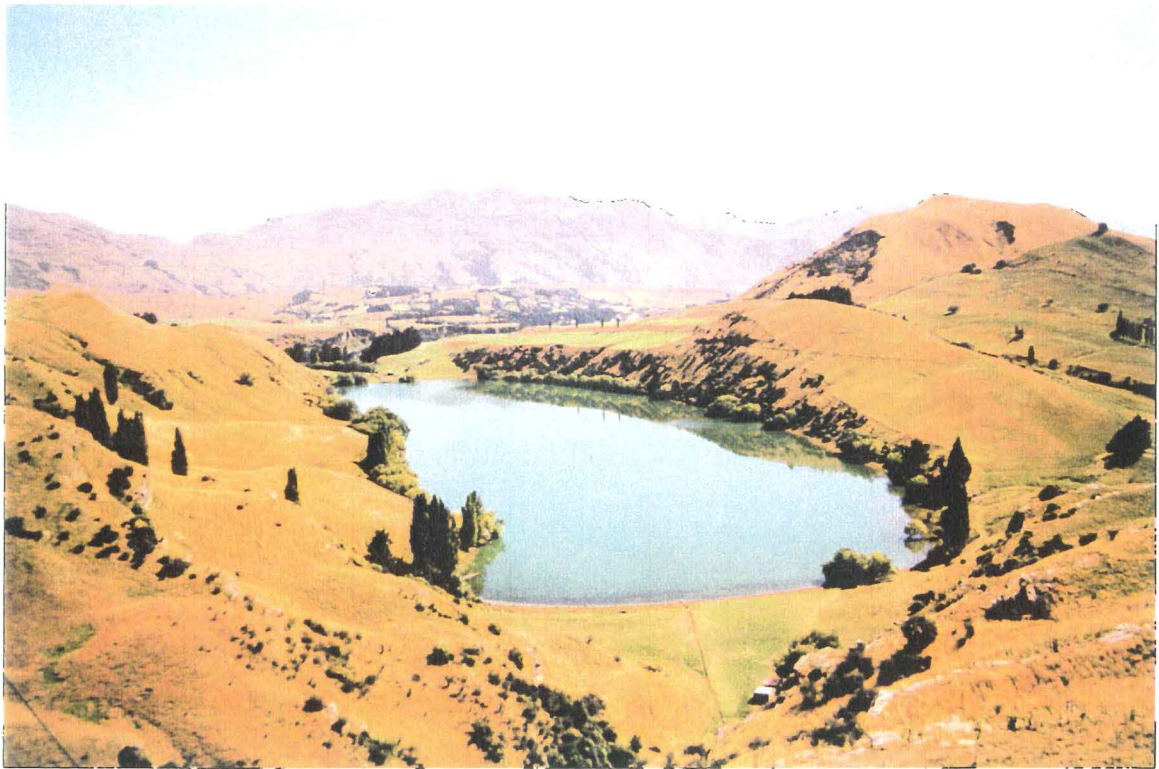
Figure 24: Ice-excavated bedrock trough occupied by Lake Johnson. Present lake level is 399m asl, maximum depth is 26.8m.

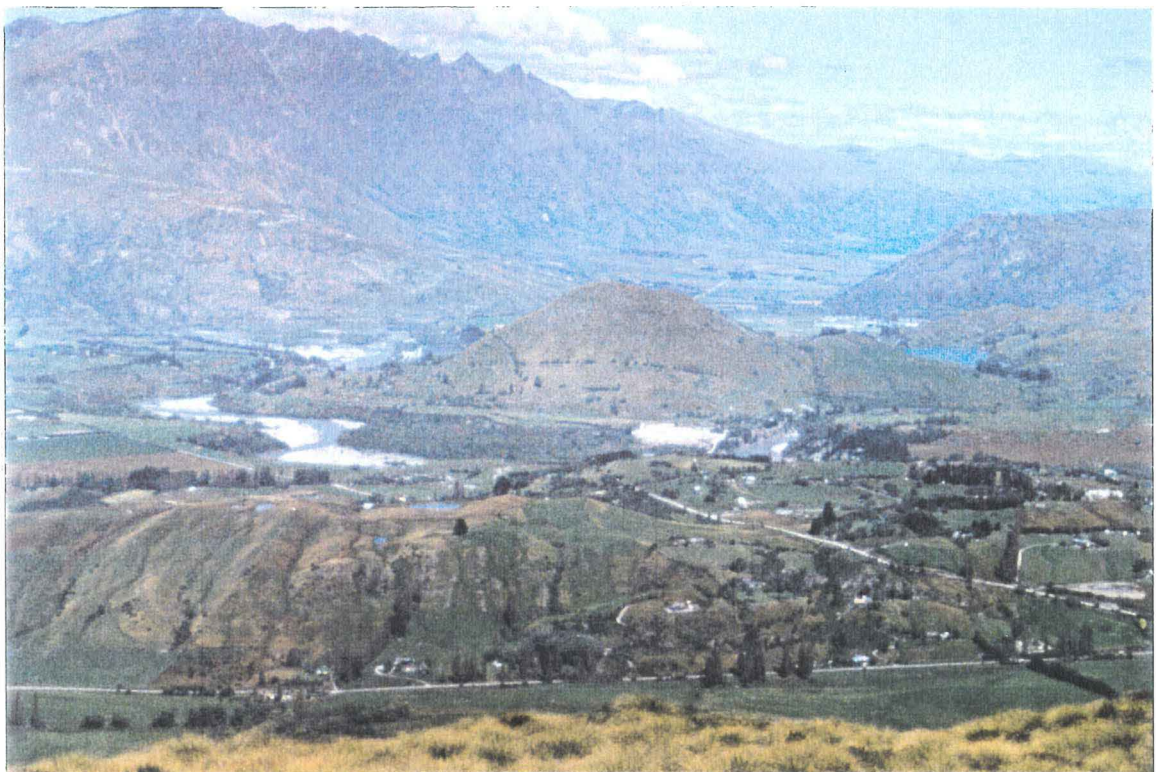
Figure 25: Ice sculpted morphology of the Wakatipu Basin. Low mamillated ridge in foreground, two roche moutonnees (Ferry Hill and Peninsula Hill, centre and to right). "Perched" Lake Johnson to the right. View is to the south.

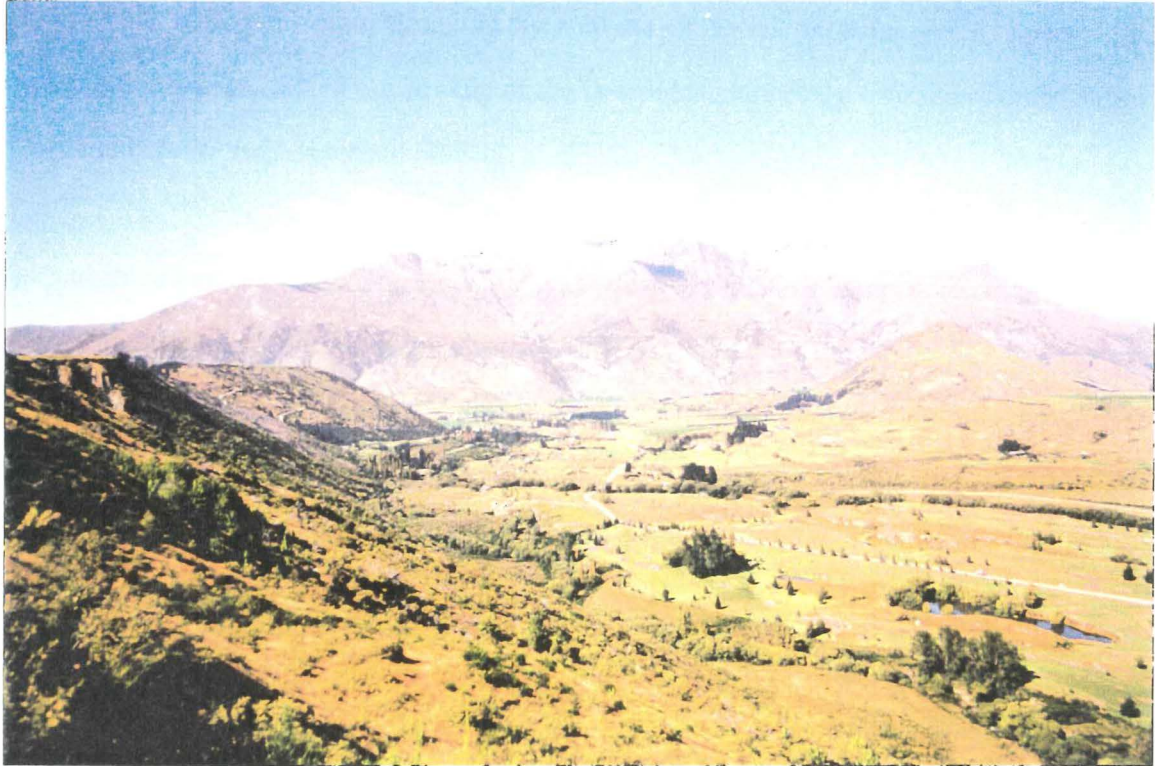
Figure 26: Slope-movement modified Crown Terrace scarp excavated by ice during the mid to late Otiran Glacial period.

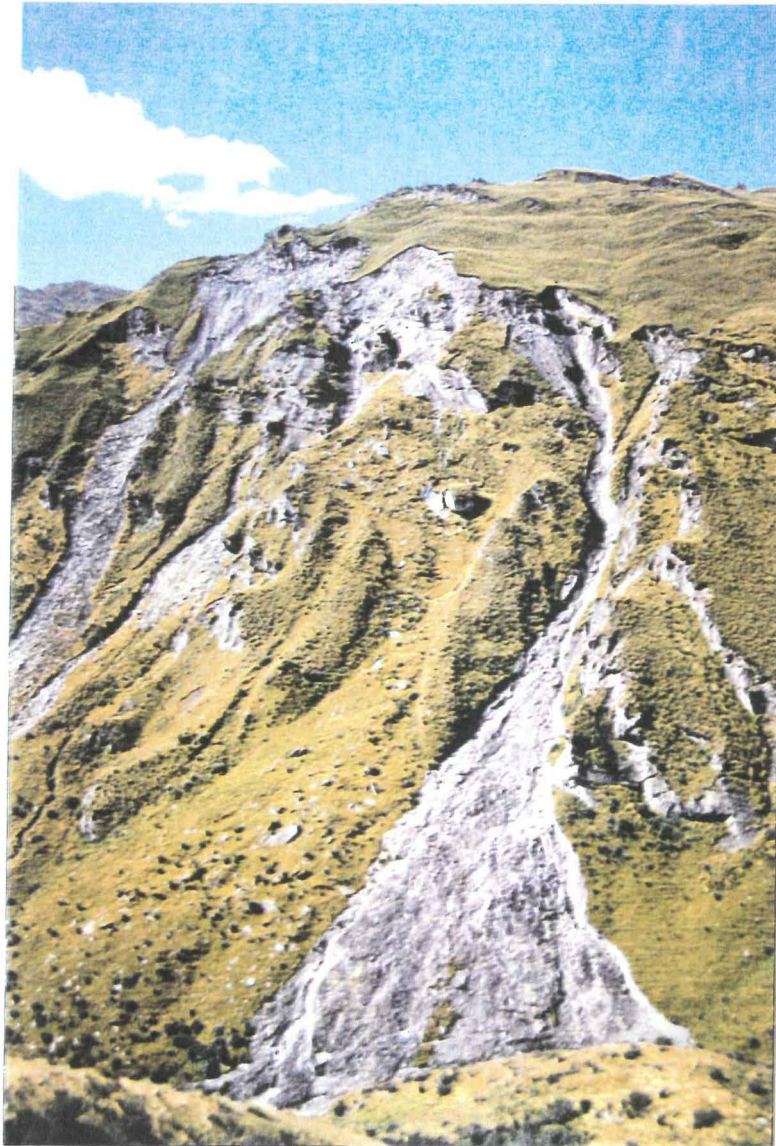
Figure 29: Debris flow reactivation of schist slide debris following heavy rain during February 1994, Skippers Road. View is to the northwest.

Present stability - no evidence for large scale movement (possibly very slow creep?), small localised areas of reactivation (Figure 29). Numerous incised streams, well established, not disrupted by debris movement on med-large scale. Future - unlikely to respond to seismic shaking (except small scale debris/rock slide?), as has presumably been sitting there for at least 10,000yrs - has most likely been subjected to large earthquakes in that time. Compare Cromwell Gorge slides no evidence of large scale movement for 16 - 50,000 years, and no evidence of rapid large scale mvt (Gillon and Hancox 1991). No problems associated with skifield development on upper slide mass.

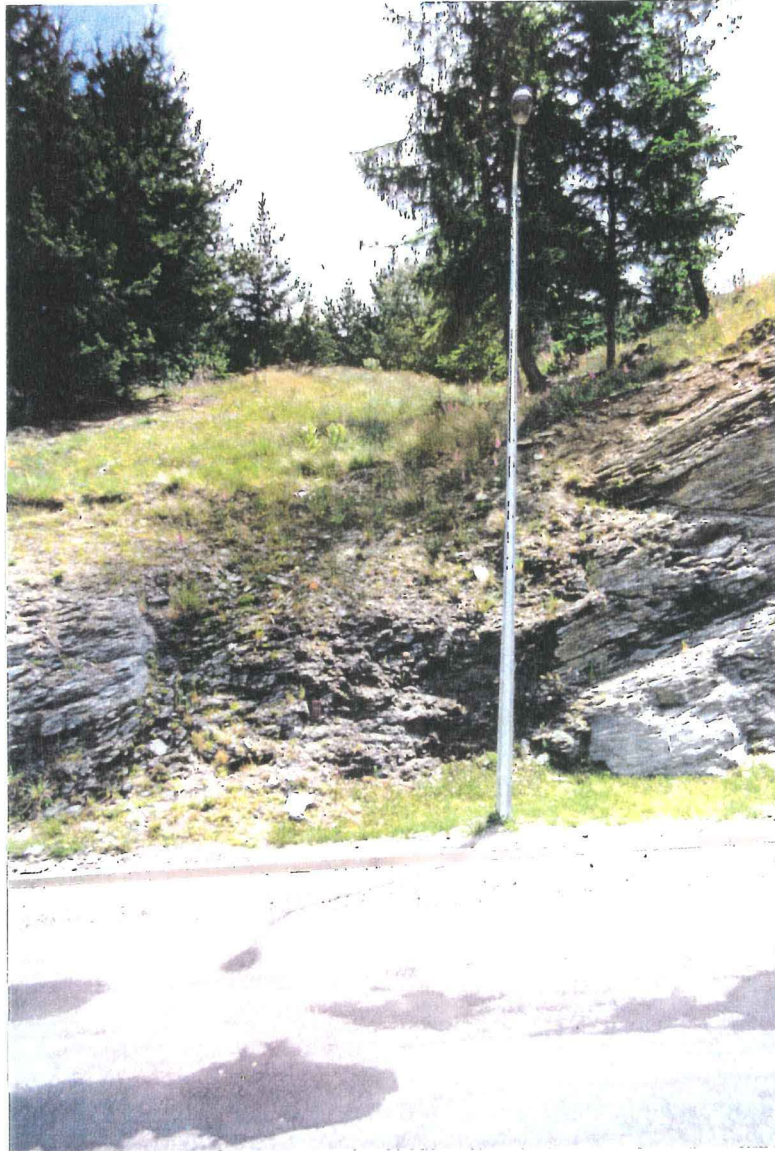
Figure 30: A 2.5m wide subvertical shatter/crush zone in psammitic greyschist, Goldfield Height road. View is approximately to the northwest along the trend of the zone. Note; very closely jointed to shattered rock on left side of zone, is more crushed towards the right. Also note that exposure is wet from seepages.

Problems most likely to be encountered during excavation and construction include wedge and/or planar block slides, and rock falls and/or topples controlled by intersecting foliation and defect planes. Extensive zones of crushed and shattered schist will constitute relatively weak areas of foundations. the presence of groundwater seepages can cause a variety of secondary problems, including the erosion of exposed crush zones.

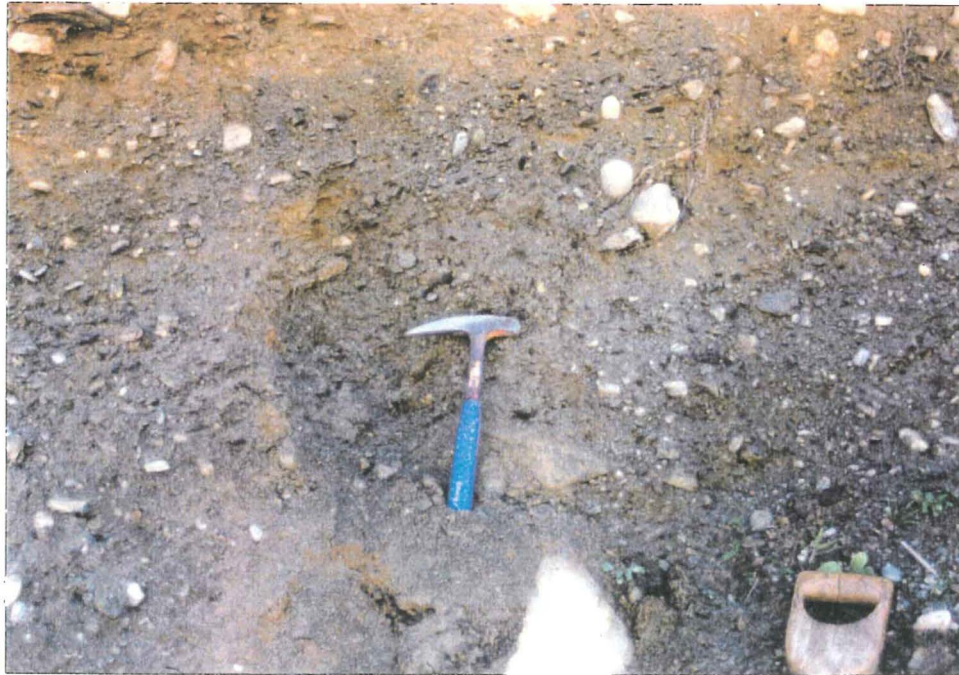
SAMPLE: A1

Figure 31: Engineering geological description of Sample A1

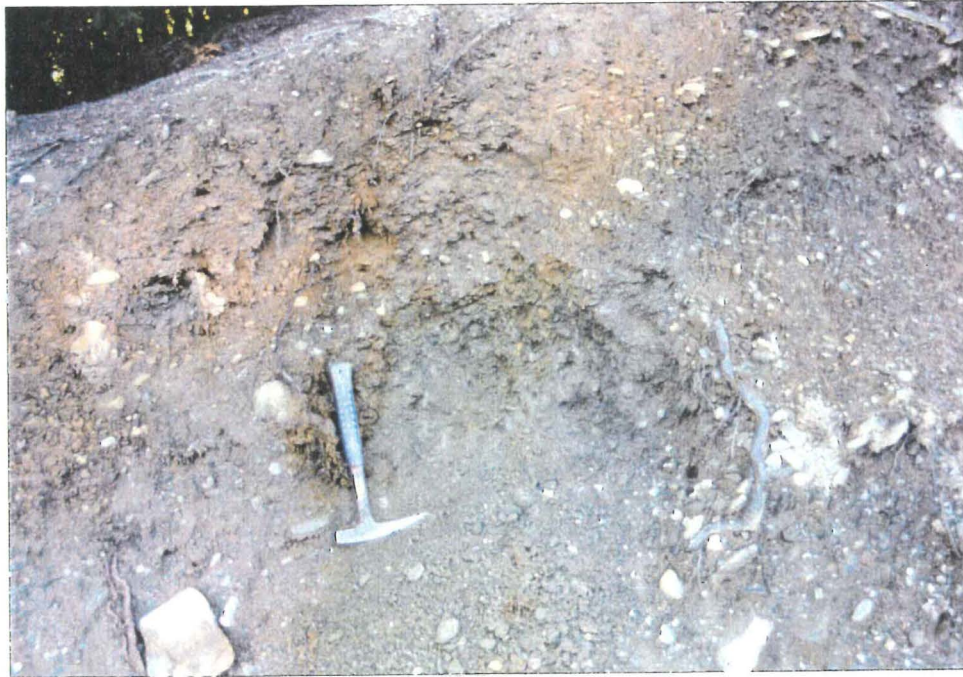
SAMPLE: B

Figure 32: Engineering geological description of Sample B

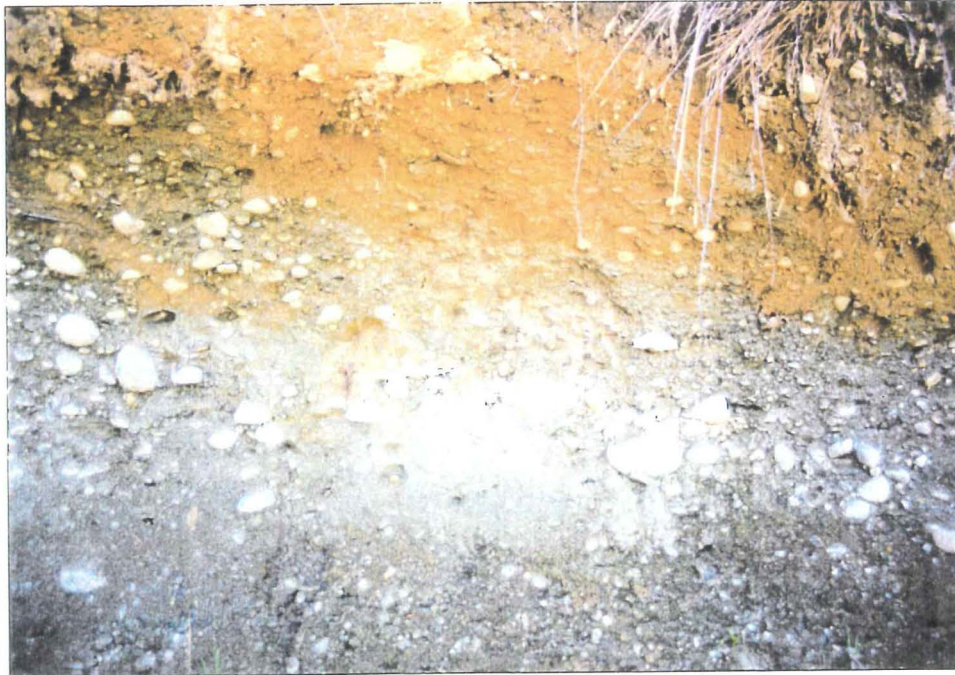
SAMPLE: P

Figure 33: Engineering geological description of Sample P

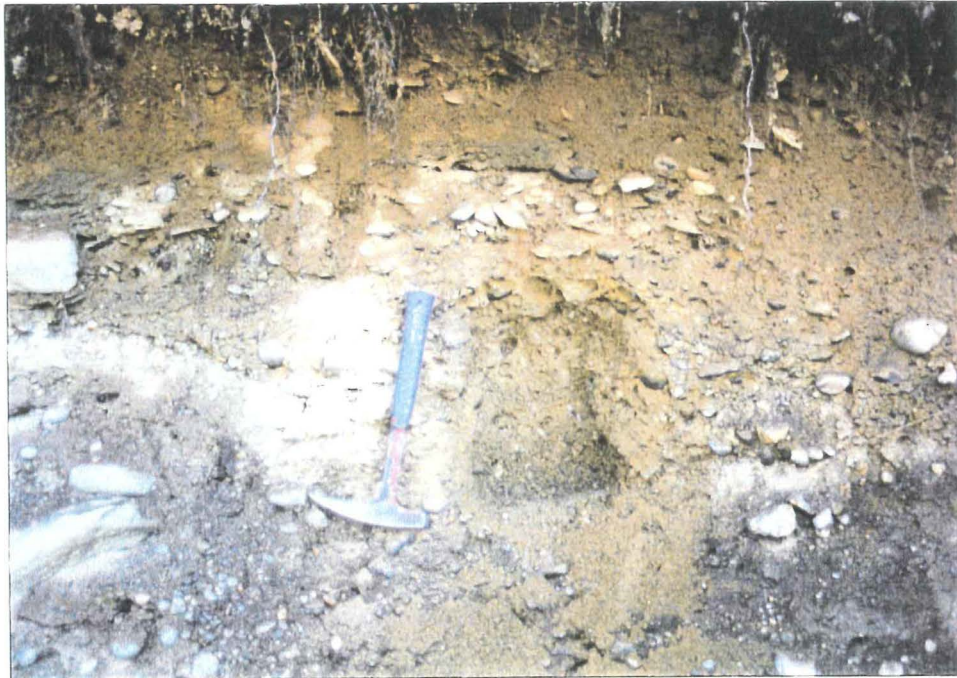
SAMPLE: L

Figure 34: Engineering geological description of Sample L

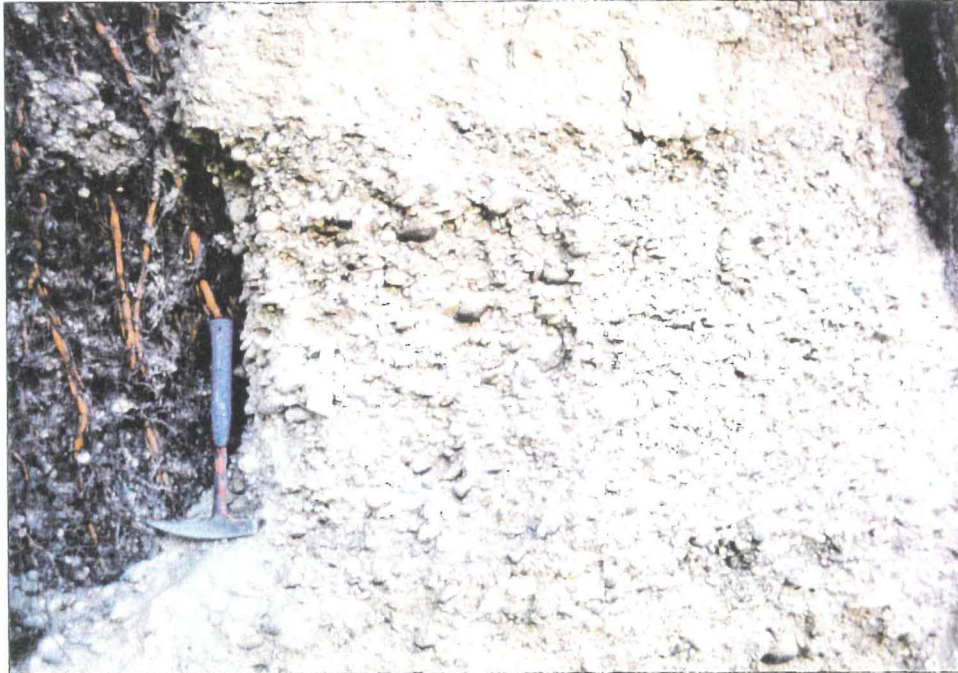
SAMPLE: N

Figure 35: Engineering geological description of Sample N

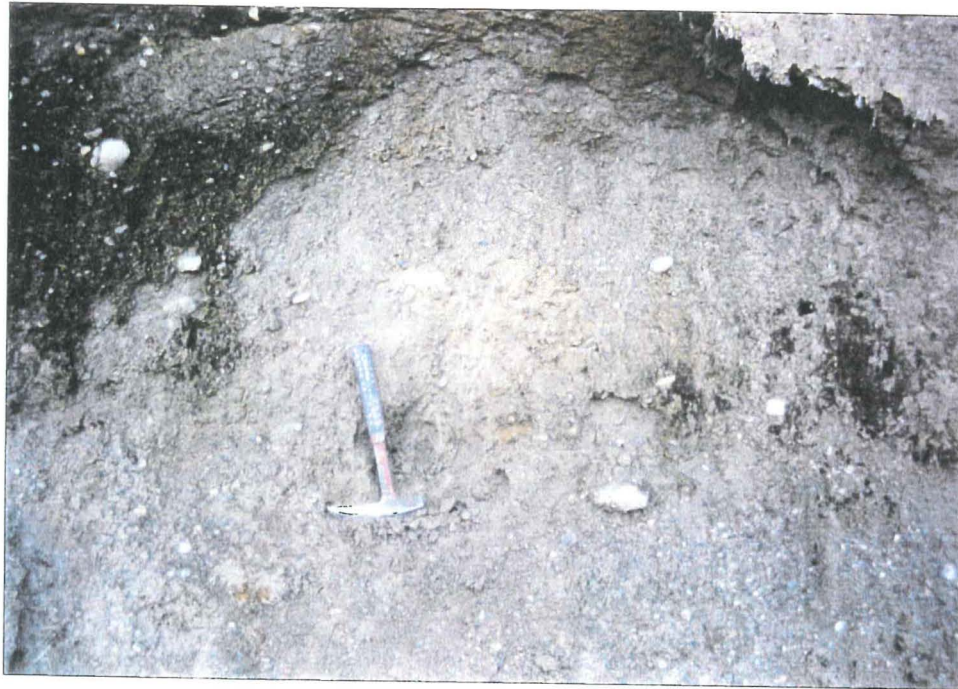
SAMPLE: C

Figure 37: Engineering geological description of Sample C

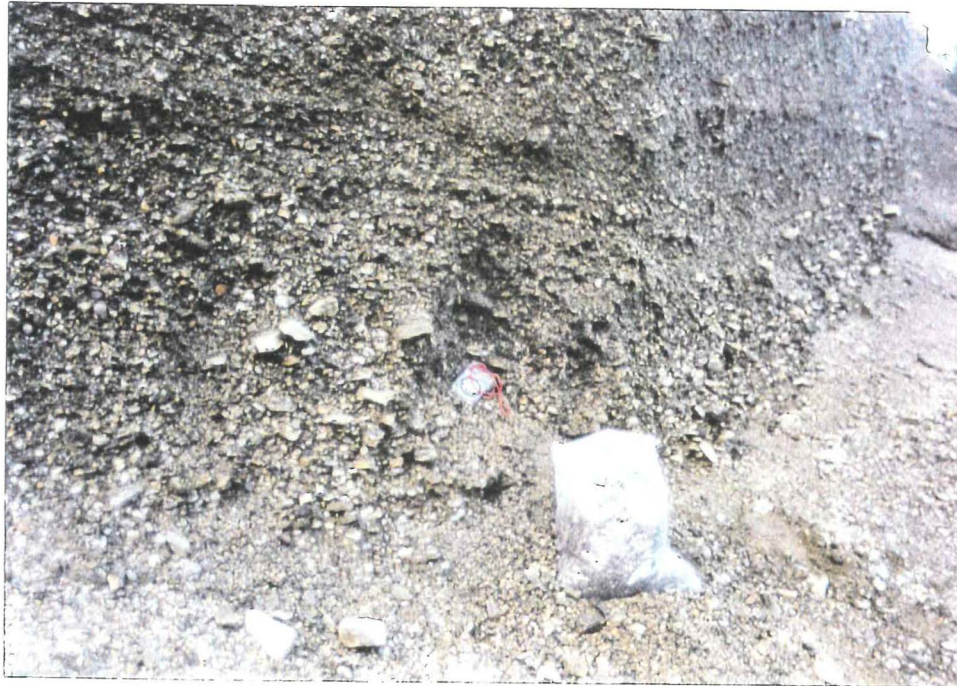
SAMPLE: D

Figure 38: Engineering geological description of Sample D

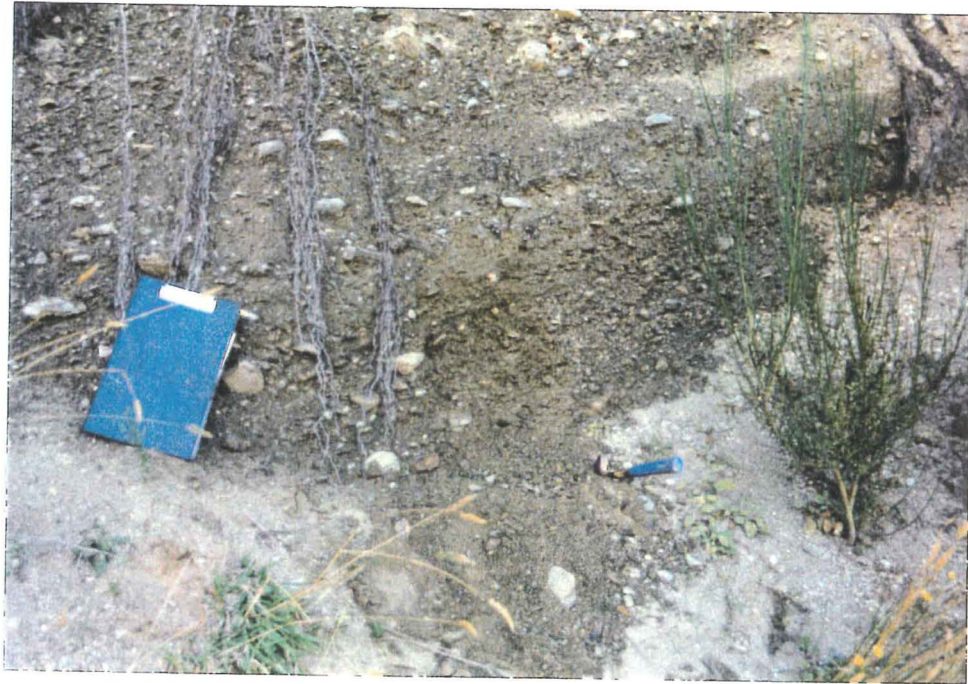
SAMPLE: E

Figure 39: Engineering geological description of Sample E

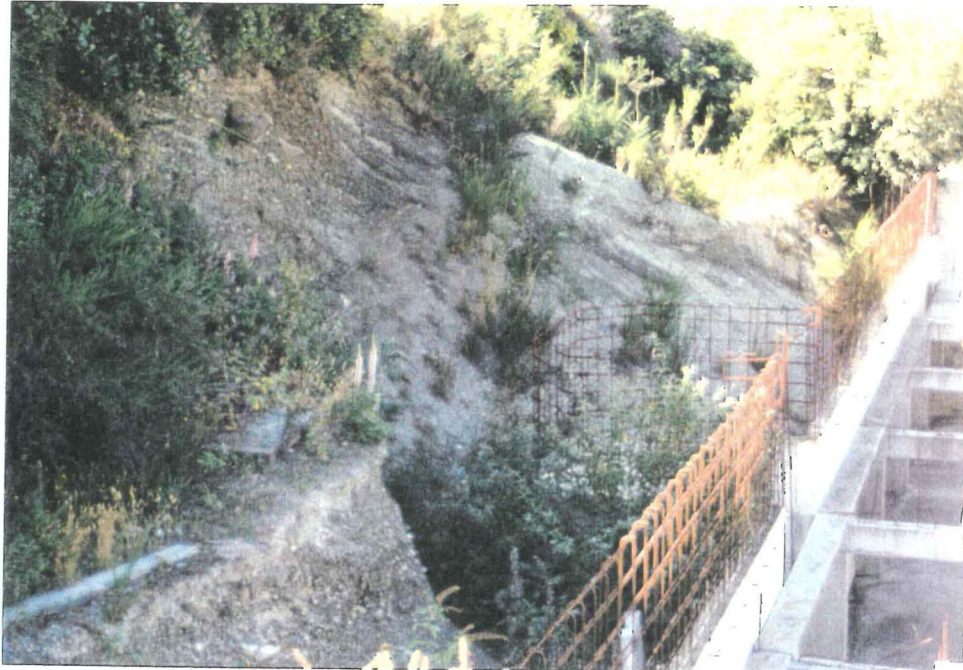
SAMPLE: F

Figure 40: Engineering geological description of Sample F

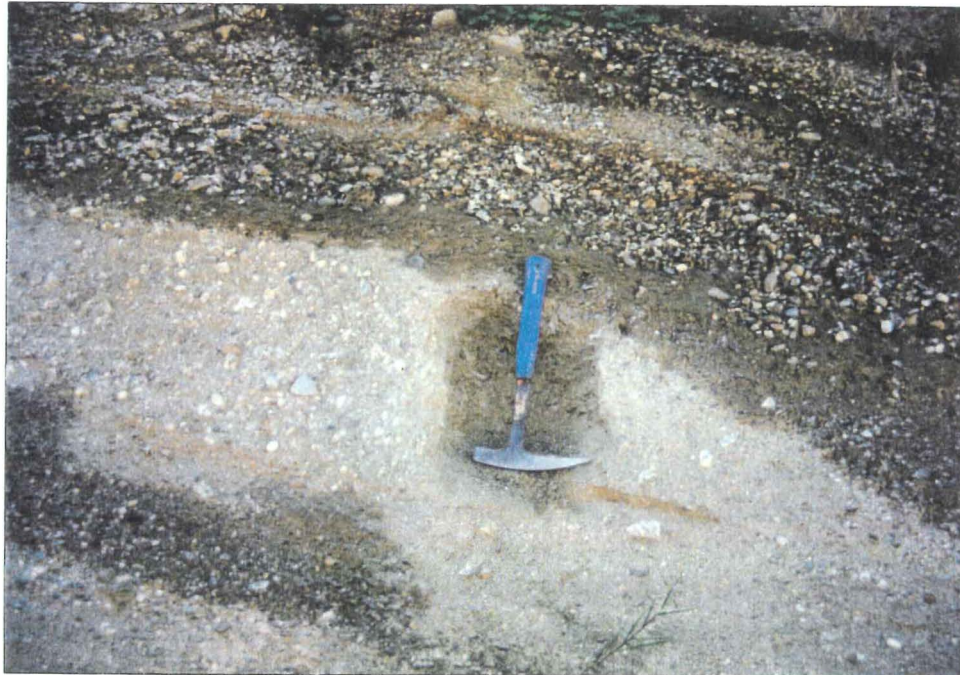
SAMPLE: M

Figure 41: Engineering geological description of Sample M

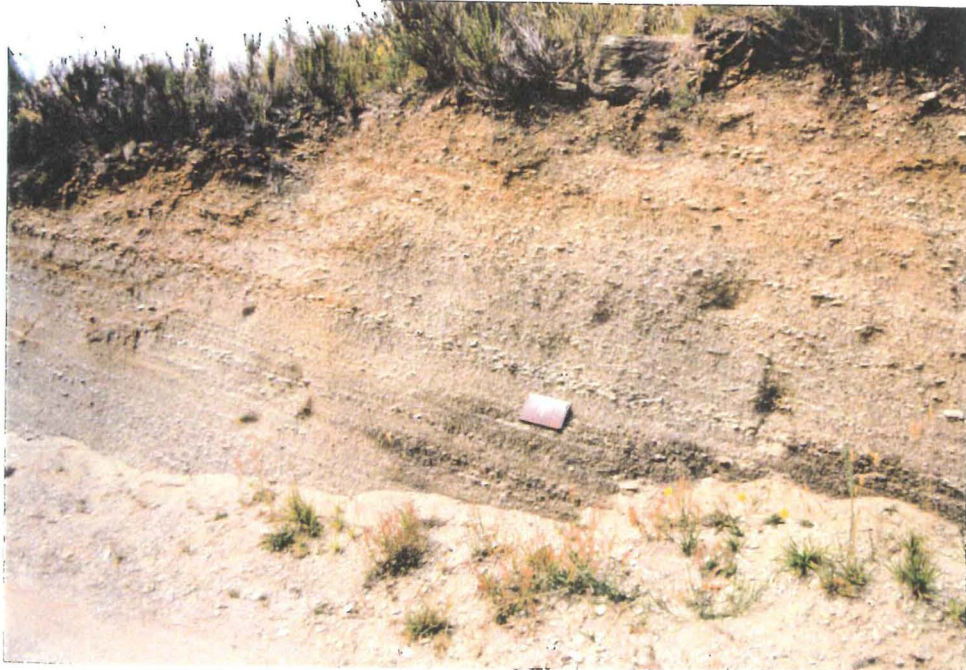
SAMPLE: H

Figure 43: Engineering geological description of Sample H

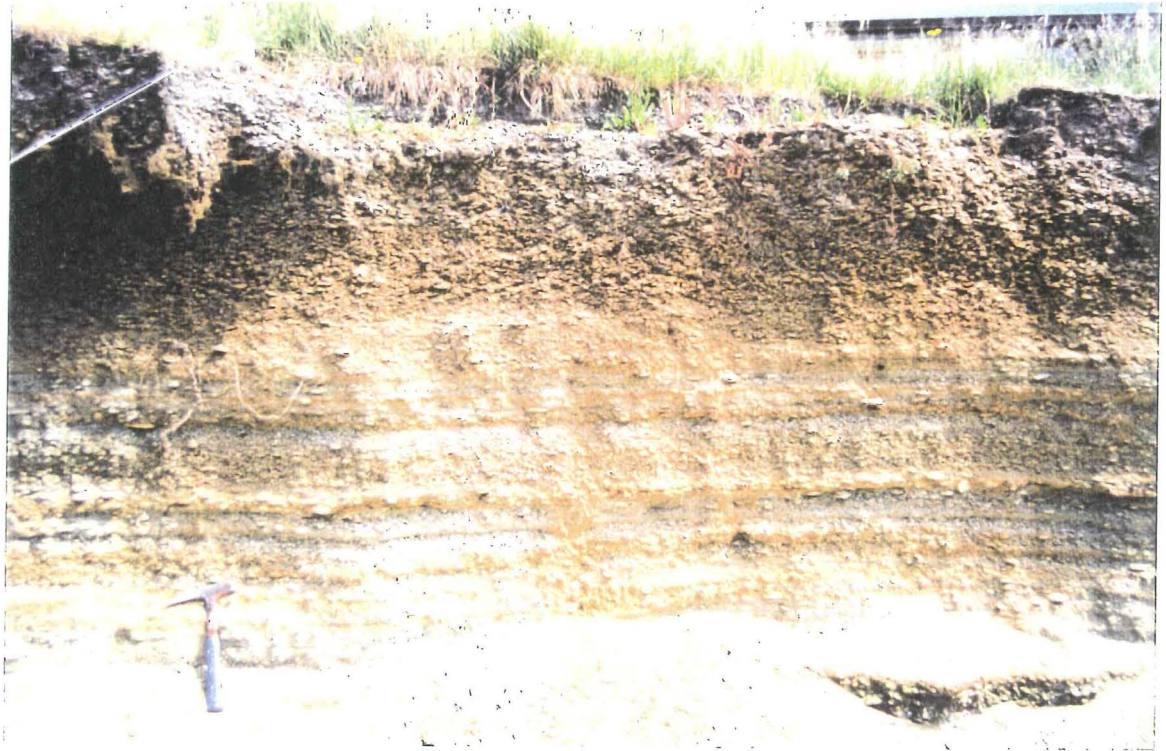
Figure 44: Layered fine to medium discoidal, imbricated beach gravels exposed in a foundation excavation near Remarkable Crescent, Frankton. The gravels are gently inclined towards the viewer.

Investigations at sites in Queenstown have found that the beach gravel deposits have a bearing capacity in excess of 100kPa at less than one metre depth, providing that no lacustrine silts are present (RC 92169, 7272). The gravels are free-draining, usually dry, and no seepages have been associated with them. Due to their often loose, "free-running" nature, some of the gravels have the potential to cause problems in excavations. The angle of repose has been estimated at $\phi = 30^\circ$ for gravels, and $\phi = 35^\circ$ for sandy gravels (RC 7309).
